AIRCRAFT ACCIDENT REPORT

(OAS/2006/11/10/F)

**Report on the Accident Involving
OAS, Registration 5N – BHU, Along the road to
Delta Steel Company, Ovwian, Aladja,
(Near Osubi Airstrip), Warri, Delta State which
occurred on 10th November, 2006.**

Aircraft Accident Report No: OAS/2006/11/10/F

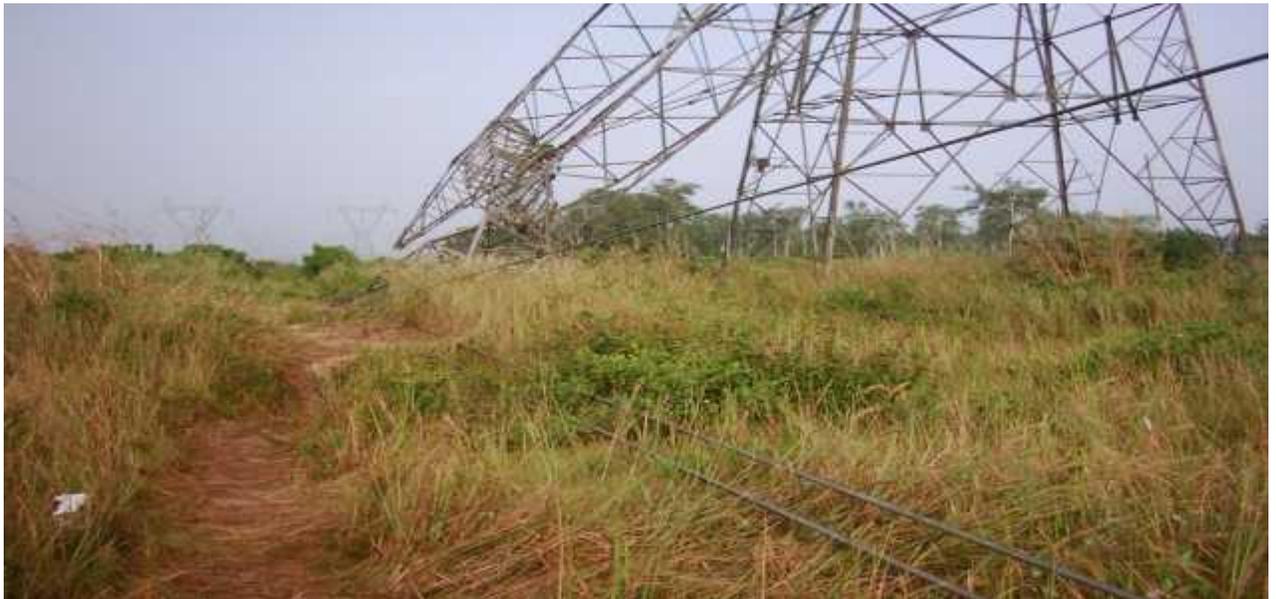
The PHCN Tower structure was pulled down when the rotor blade struck the power transmission cable.

The Helicopter's main rotor blades impacted the PHCN high tension cables and intertwined with them. As a result, the nearest PHCN tower structure (about 27m high) was pulled down and the helicopter crashed into a grassy field as shown in Figures 1 & 2 below.

Fig. 1: Photograph showing the damaged PHCN Tower Structure

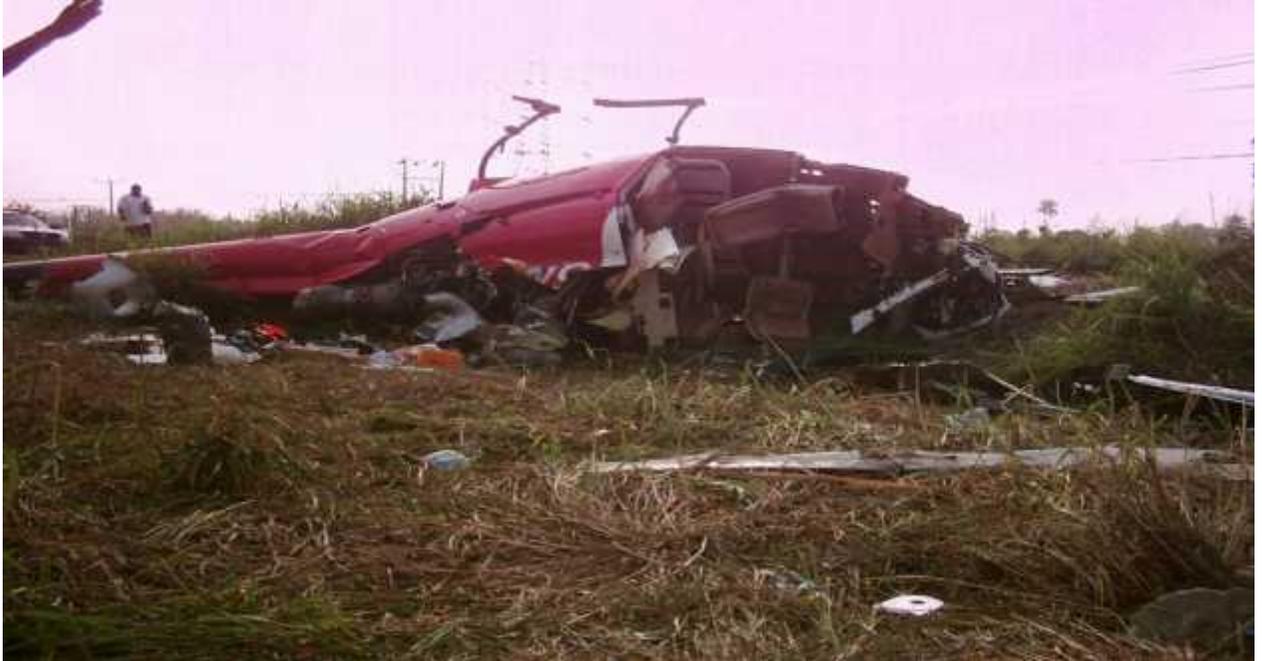
The aircraft's wreckage was confined within a small area as shown in the photograph.

Fig. 2: Photograph showing the wreckage at its final resting position

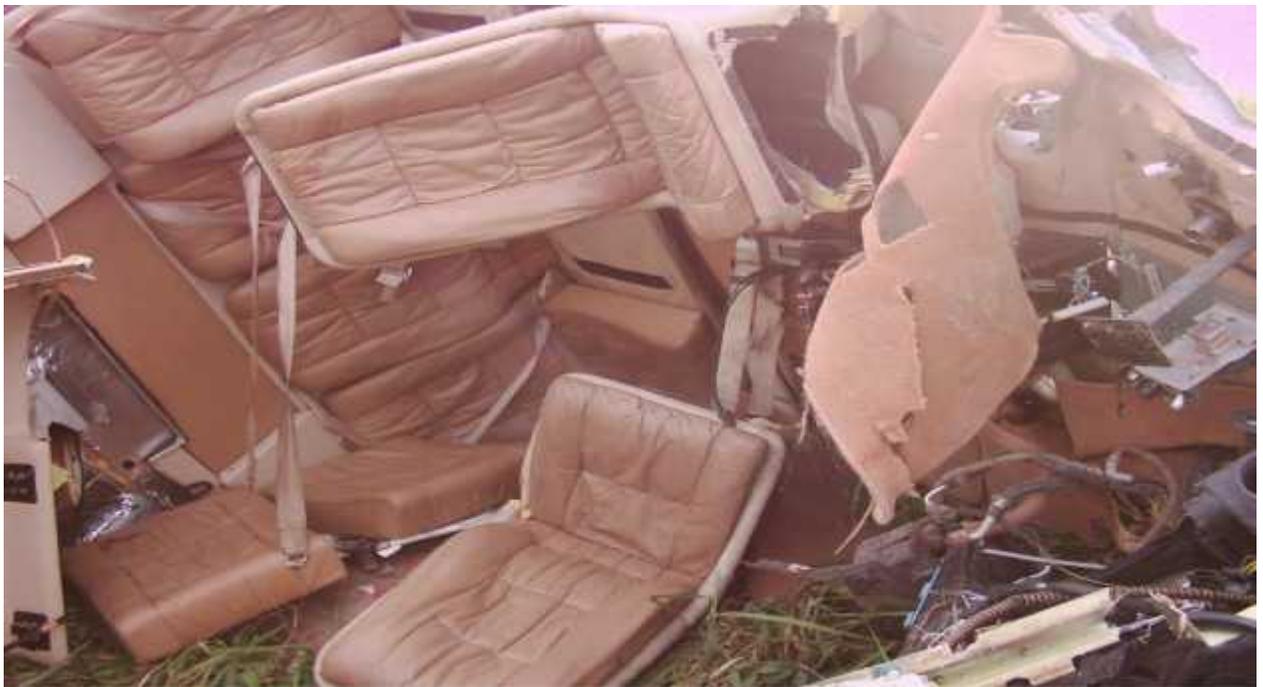
The rescue operation was initially carried out by eyewitnesses and passers-by as the accident occurred along a major highway and fire service personnel moved on time to the crash site located at about 6NM to Osubi Airstrip. Three persons were evacuated from the wreckage while the fourth person was fatally injured and found outside the aircraft. There was a liveable volume for the occupants to survive after the crash.

Fig. 3: Photograph showing a relatively intact Cabin seats after the crash

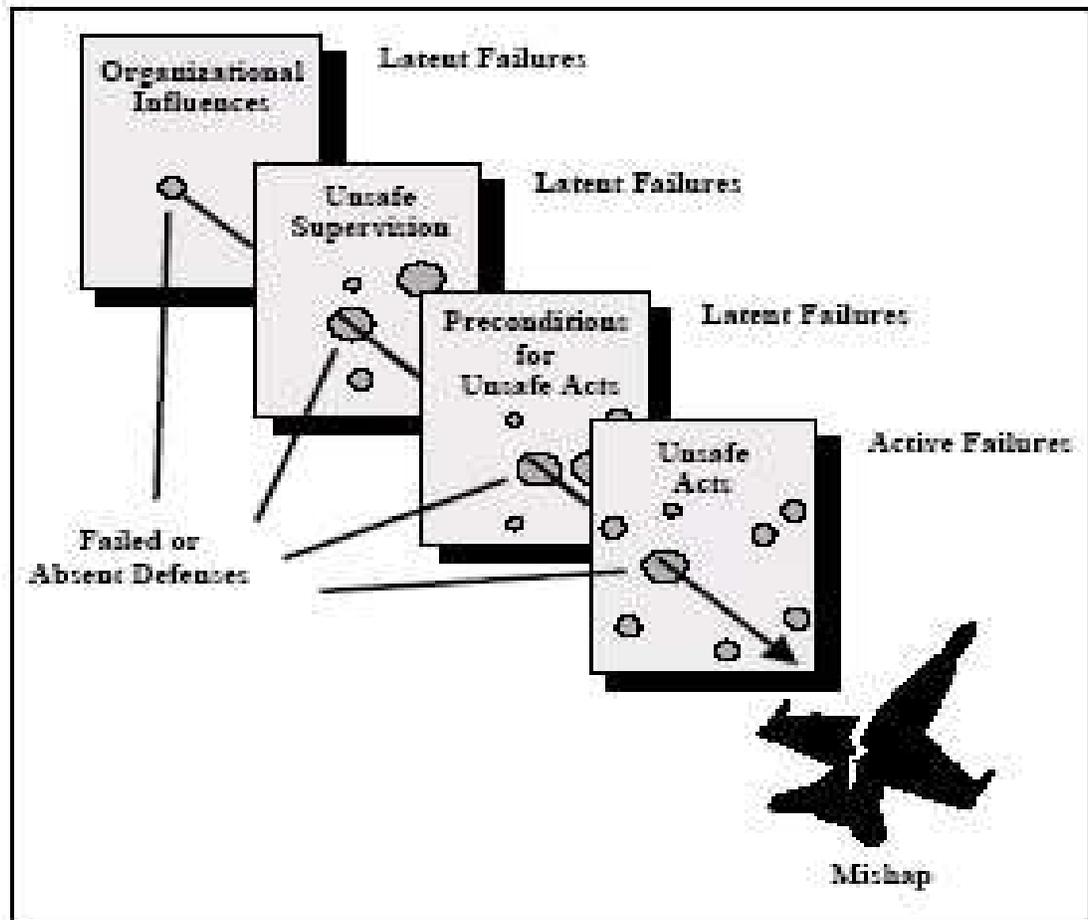
Summary of Human Factor elements in this accident as illustrated in the Cheese model of accident causation above are as follows:

Organizational factor was evident in the company’s engagement of crew with insufficient qualification/training who possessed only the Commercial Helicopter Pilot Licence but no instrument rating as required in its Operations Manual.

The gap created by the exit of the company's engineer who was type rated on the helicopter that prompted the pilot to sign the Certificate of Release to Service for the first flight of the day was a precondition to unsafe act.

The decision of the pilot to take off from the operator's Maryland heliport by making a blind transmission to Lagos Tower without proper ATC authorization in such a busy airspace as well as his decision to descend below 500ft in an attempt to carry out a precautionary landing without a clear visual reference when diverting to Osubi airstrip enroute Porthacourt constituted unsafe acts.
