FEDERAL REPUBLIC OF NIGERIA  
MINISTRY OF AVIATION LAGOS.

REPORT ON THE ACCIDENT TO THE OKADA AIR  
BAC 1-11 REGISTERED 5N-AOT  
PORT-HARCOURT INTERNATIONAL AIRPORT  
ON THE 7TH SEPTEMBER, 1989.

CIVIL AVIATION ACCIDENT REPORT  
NO. CIA. 148

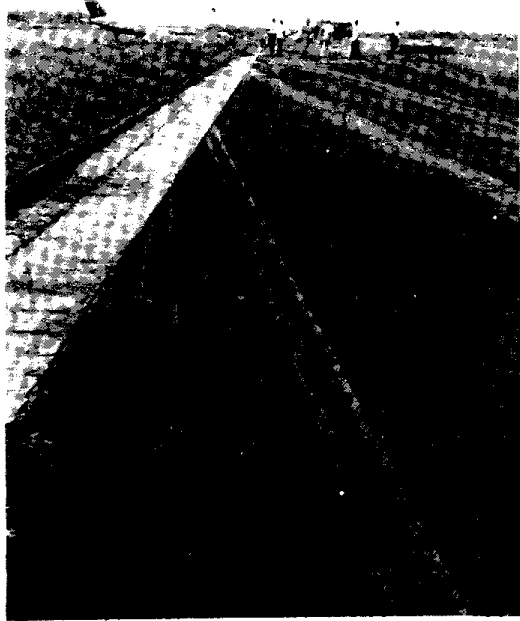
A

After the aircraft lost the two nose-wheels. the axle flanges started to cut grooves onto the runway surface until the nose-gear strut collapses and the aircraft's nose, under the Radom, came in contact with the runway and every ground directional control was lost. The aircraft now drooping nose-down, continued the landing roll towards the left side of the runway onto the unsafe shoulder. (please see picture in the Appendix). The aircraft remained on the paved runway for 660 meters from the touch down point before running into the trench which had been partially refilled with loose soil.

Photograph showing the left main wheel tyre and the nose section marks on the runway after the nose gear had been broken off.

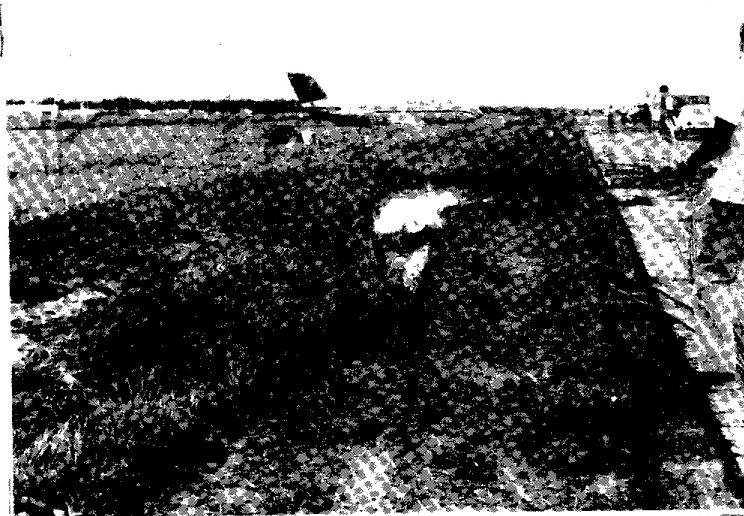
B

The filling did not serve the intended purpose - "to be able to sustain the weight of aeroplane which might be running off runway". Just as had been the case m the previous landing accidents on runway 03/21 of Port-Harcourt International Airport, Flight OKJ 307.anded kip, down in the trench and suffered the same catastrophe.

The runway shoulder showing pool of water where the main wheels ran into the poorly filled trench.

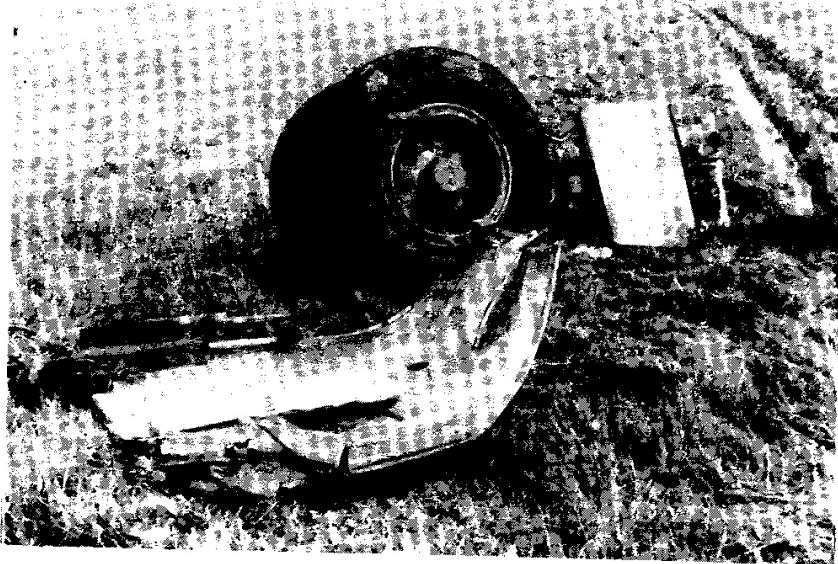
A

The right main landing gear ran into the loosely tilled trench and became detached from its pintle bearing in the wheet well cavity before the aircraft came to rest about 95 metres from the trench.

The severed right landing gear after running into the trench.

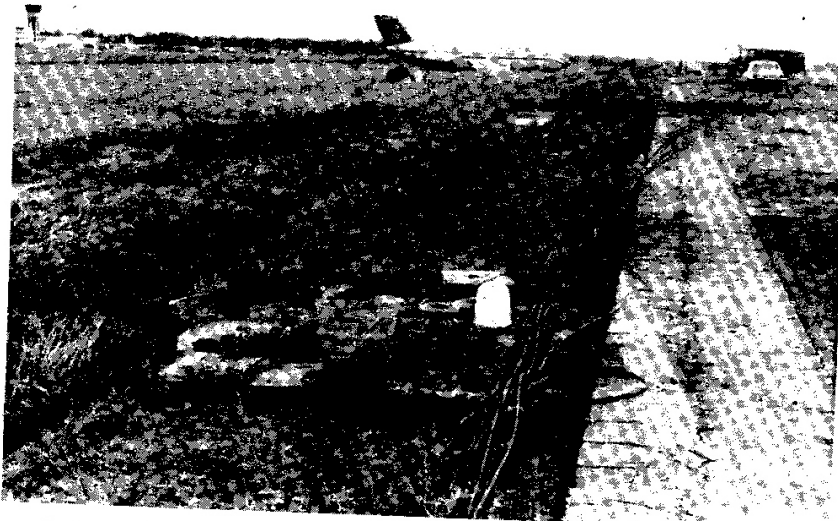
B

Port-Harcourt's runway 21 is 3000 metres long and along this length at the left shoulder trenches were dug which had now partially been re-filled with soil but not well compacted as to sustain the aircraft weight. Information was given that the trenches were dug there in 1986 so that the buried runway lighting cables, which were incessantly being short circuited by water log, could be brought to the surface and laid along the runway length. The trenches were recommended to be re-filled after they have catastrophically contributed to some landing incidents. The earth re-filling job was haphazardly performed that the trench continued to remain dangerous to any aircraft which was forced to use the runway shoulder,

As at the time of this accident, some parts of the trenches still remained uncovered or half-filled with earth. At the point where this aircraft ran off the runway the partially filled trench was so soft but a shovel pushed into it was completely emersed into the mud up to its handle. (Please see Appendix., ... -

The contributory factor to the accident is the excavation and improper refilling of the outrageous trenches of wide dimensions along the length of runway 03/21.

Photograph showing the type of hazardous refilling job performed along the runway shoulder.

At each instance of the above accidents, reports have strongly recommended the trenches for permanent closure and that the runway shoulder should be brought back to its original status of "aircraft weight bearing specifications" as specified by ICAO Document 9167-AN/901 Part 1.

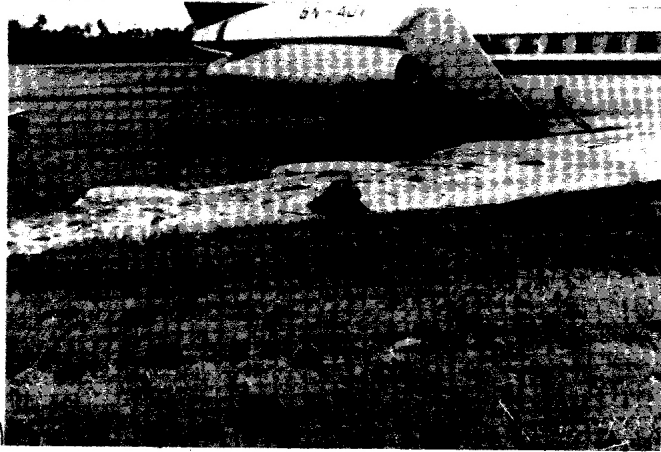
A

The bird dispersal mechanical gun placed on the runway shoulder was crushed and its cylindrical gas tank became imbedded into the leading edge of the aircraft. Two runway edge light fittings were knocked off, one runway edge light isolating transformer was damaged and different sizes and lengths of edge light cables were damaged or severed.

The right wing in contact with ground and showing the imbedded bird dispersal gun's gas tank.
